# 2025

## Monroe County Water Quality Study

### Monroe County Planning Commission

### Monroe County Conservation District

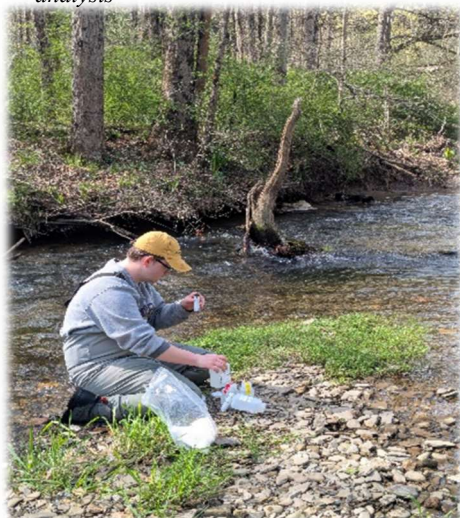
Figure 1: Sample collection for lab analysis

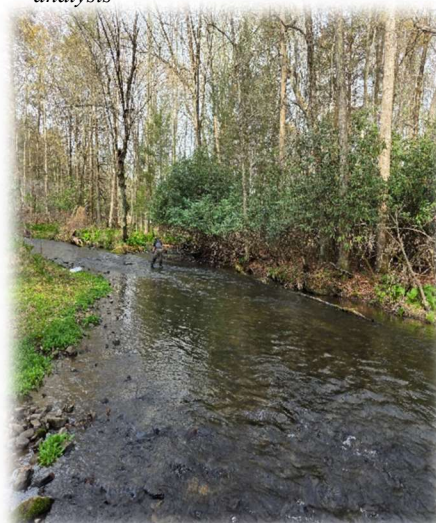
Figure 2: Sample collection for lab analysis

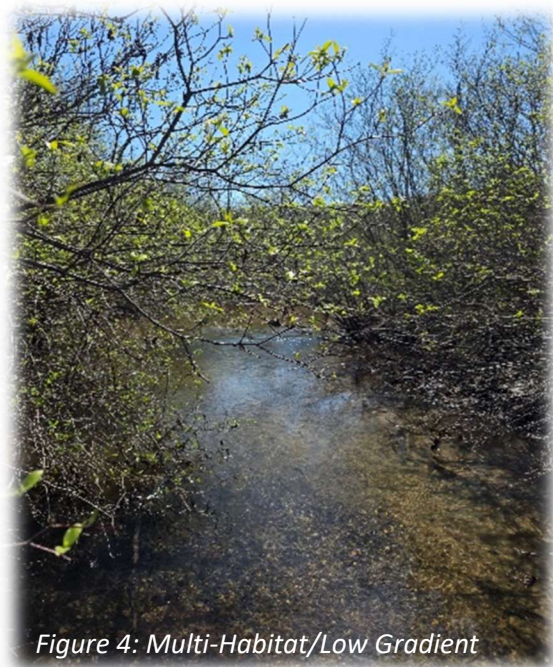
Multi-Habitat/Low Gradient Collection – Ten samples within 100-meter reach

- Cobble/Gravel
- Snag
- Coarse Particulate Organic Matter (CPOM)
- Submerged Aquatic Vegetation (SAV)
- Sand/Fine Sediment

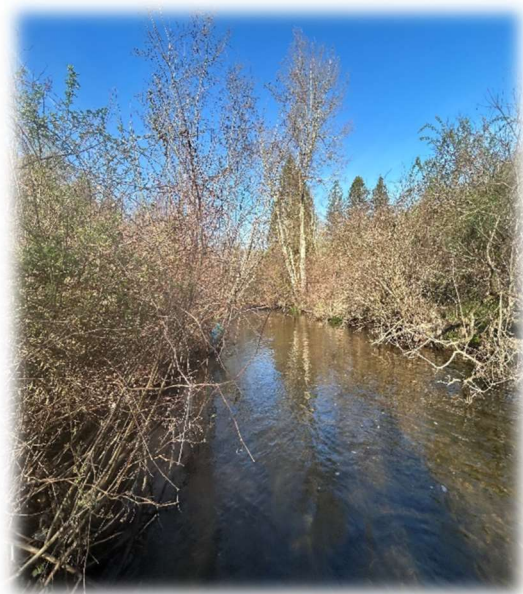
Epifaunal Substrate/Available Cover  
Pool Substrate Characterization  
Pool Variability  
Sediment Deposition  
Channel Flow Status  
Channel Alteration  
Condition of Banks  
Bank Vegetative Protection  
Riparian Vegetative Zone

*Figure 6: Multi-Habitat/Low Gradient*

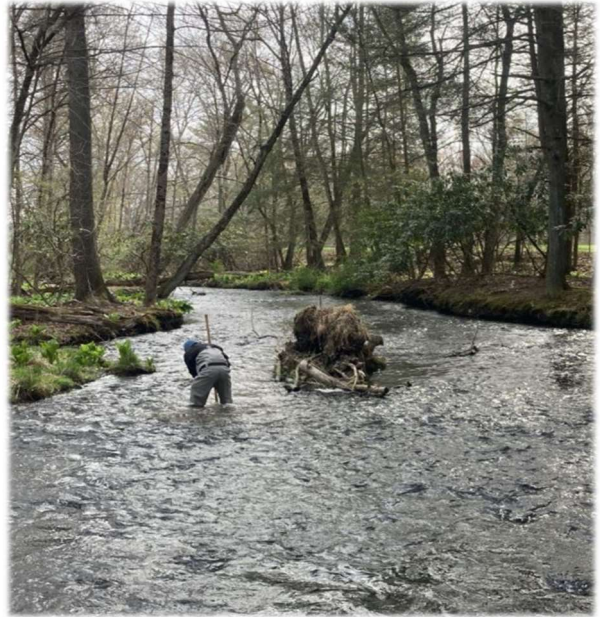
Figure 7: Collecting macroinvertebrates.

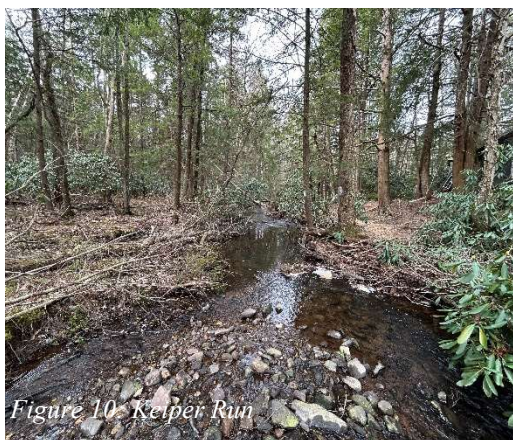
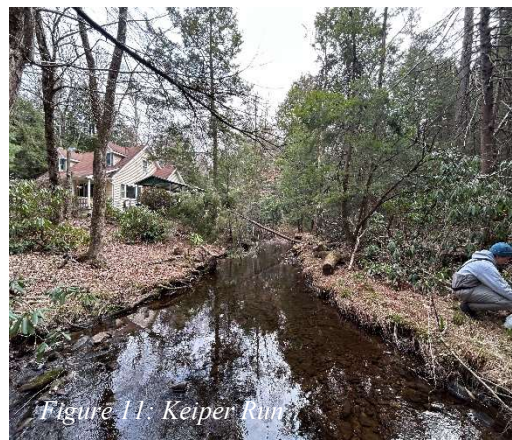
- Land use surrounding the headwaters of Keiper Run have been altered by development.
- In 2019, bank erosion resulted in a large sediment pollution event upstream of the SR 115 Bridge over Keiper Run. Evidence of the discharge is still visible downstream from the road. Parts of the channel are continuing to erode upstream of the bridge.

- Approximately 0.25 miles upstream of the sample site, Keiper Run flows through a low gradient (~1% slope) wetland complex before prevalence of higher gradient riffle/run habitat begins. Low gradient wetlands are optimal habitat for Chironomidae and other filter feeding macroinvertebrates.

Figure 10: Keiper Run

Figure 11: Keiper Run
